Ground improving injections underneath historical buildings: five case histories as an overview of a technique

Abstract

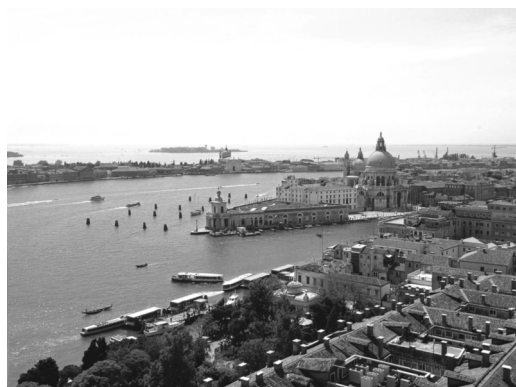
Fig. 7: Punta della Dogana view (above), map (below).

The main building has a width that varies from 16 m to 75 m and floors lie on ten brick walls, parallel to one another, as described in Fig. 7. Foundations are constituted by bricks and binder walls laying on four different substrates: directly on the soil, on a rigid shelf laid on the ground, on a shelf that lies on wooden piles or on the foundations of an existing tower. The foundation base level varies from 0.69 m to 2.84 m depending on the position.

«Punta della Dogana» is a historical place in Venice where trade occurred. The trapezium-shaped buildings were built in 1677 on the basis of the design of the architect Giuseppe Benoni (Fig. 7).

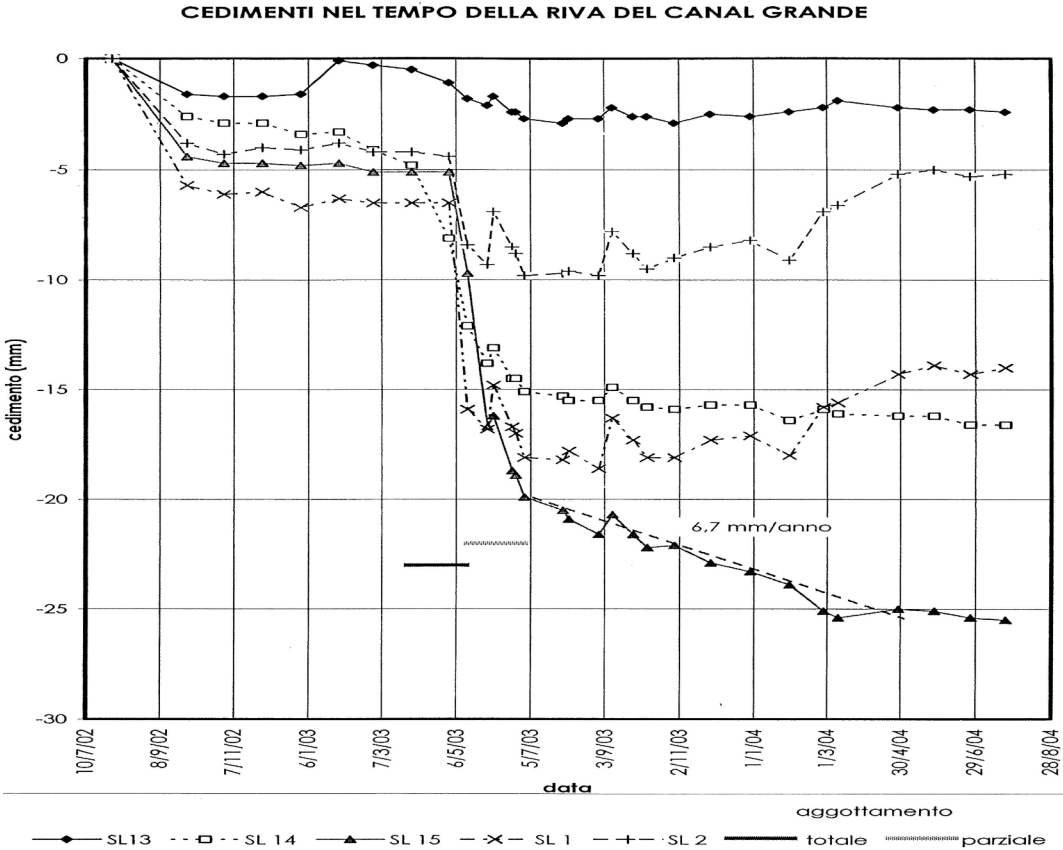
Fig. 8: Time-settlement curves of several anchorages (x-axis: date, y-axis: settlement in mm).

In May 2003, during the restoring of the «Canal Grande» shore walls (the main channel in Venice) by means of micropiles, settlements of the wall near the «Punta della Dogana» together with settlements of the building itself occurred. These caused old cracks to open again, and new ones to be created. Three mechanisms were responsible for this: vertical differential settlements, elongation in the direction of the internal walls, and rotation of the facades, especially the one towards the «Canal Grande». At that time the shore walls were already being monitored and the monitoring was continued after the episode, highlighting a settling trend. Assuming the zero corresponding to the measurement of 31.07.2002, the settlement-time curve plotted in Fig. 8 shows a sharp increase in terms of settlements between 30th April, and 15th May for all the anchorages, especially SL15 that is in corre-

spondence of the «Canal Grande» and continues settling even the year later whilst the others stop.

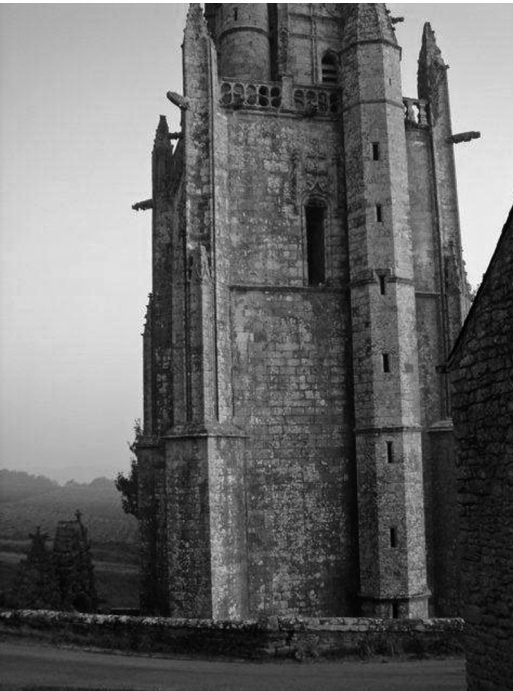
Fig. 11: The Chapelle Saint Nicodème leaning tower.

In 1914 cracks due to problems in the tower foundations were detected. A geotechnical survey carried out in 1926 revealed that the ground was constituted mainly by shale which was loose and sensitive to moisture

and this is probably the reason for the instability of the tower. Between 1927 and 1930 low-pressure concrete injections were performed in order to consolidate the subsoil. In 1972, however, an inclination of the chapel towards the south was detected (Fig. 11). Moreover, during the latest survey, cracks due to water vapor and to an incorrect water canalisation were also detected. Because of the critical situation of the building, two types of intervention were planned: soil improvement and wall restoring, both by means of resin injections. The first type is the previously described Uretex Deep Injections® whilst the latter is called Uretex Walls Restoring® and consists in injections whose aim is to fill voids in joints between wall blocks with bender.

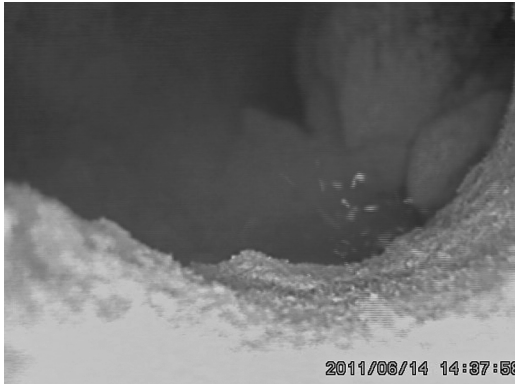
Fig. 13: Cavities in Geneva subsoil.

Visible differential settlements had already occurred at the time of construction, since the side laying directly on the soil started settling immediately. The first measurements go back to 1976 and now the maximum differential settlement between the two sides reaches 20 cm, while the rate of settlement is eight times faster than the initial one. The subsoil was also found to be constituted by several cavities, as detected during geotechnical preliminary surveys (Fig. 13).
